Inspection Summary for the Treoil Industries, Ltd. Site, Ferndale, WA.

Inspectors: Norm Peck (Ecology), Melinda Miller (Whatcom Co. H.D.)

Inspection Date: 7 March, 2000

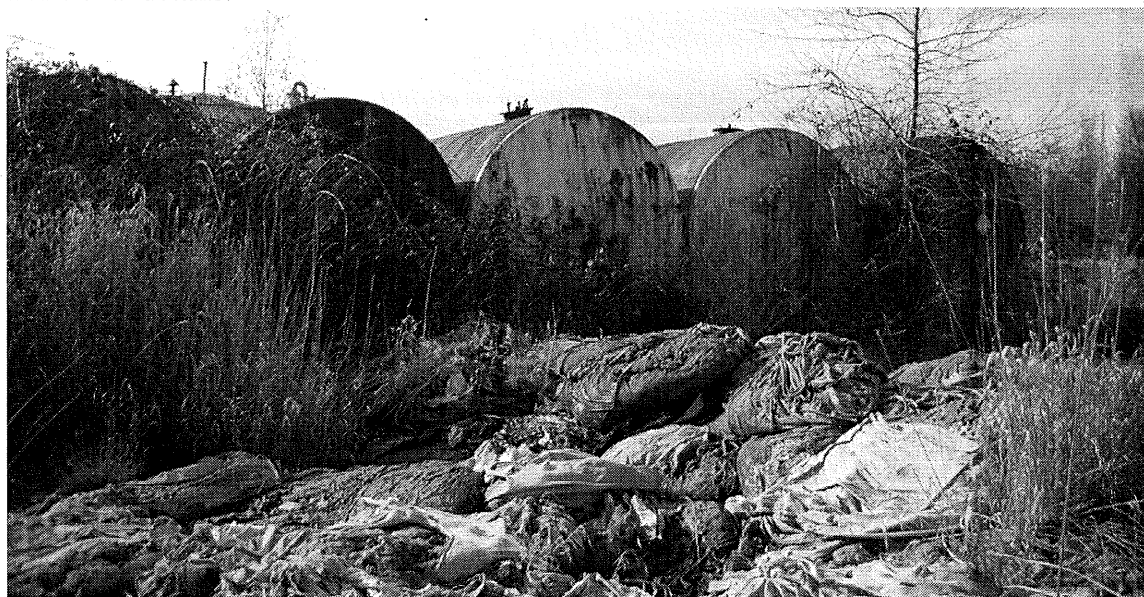
Treoil1 shows a large pile of what appears to be rosin in deteriorating fabric shipping totes immediately to the north of a row of large horizontal above-ground tanks north of and outside of the fenced area of the site. View is to the southwest. Photos by N. Peck

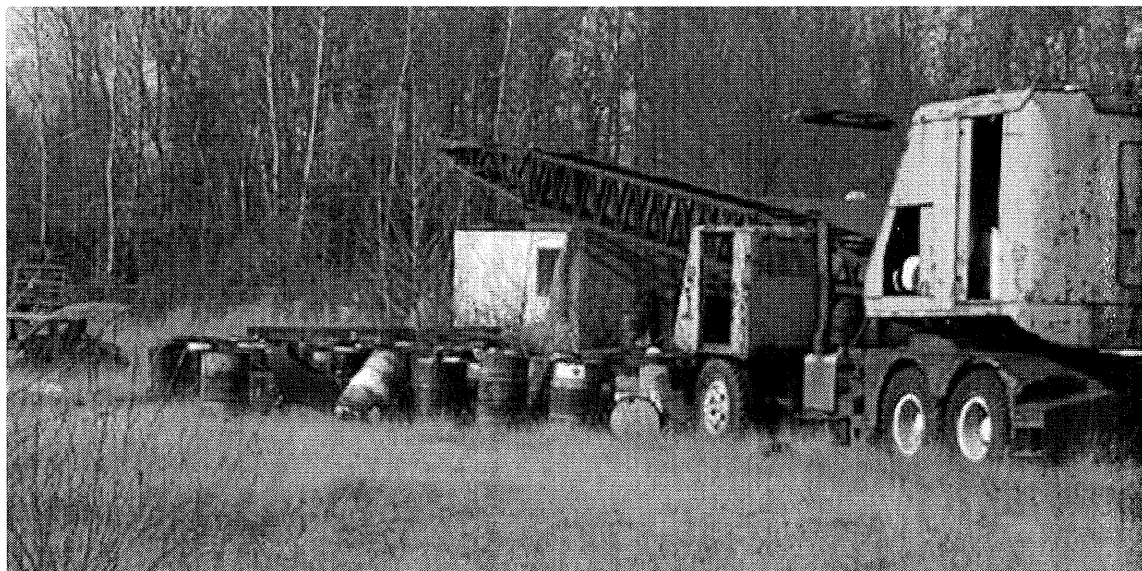
Near the center of the fence at the north side of the fenced area is a horizontal aboveground tank surrounded by about 200 drums. This area is about 125' west of the back fence opening at the northeast corner of the fence. See photo Treoil6 and Treoil6a. Several drums in this area have leaked, and much of the area is overlain with a layer of what appears to be hardened spilled material. Near the middle of the drums on the east side of this tank/drum area (Treioil7) is an area of spilled material that is not hardened. It is a thick, viscous, dark brown to amber liquid or semi-solid. This material was samples as Treoil 02. See also Treoil7-9 at the end of this report.

Treoil6a *Some of the 200 drums at this location are visible to the right of the truck-mounted crane. The south end of the lab trailer is visible behind the drums and approximately 20,000 gal. tank the drums surround. The area of extensive spillage and location of Sample Treoil02 is just in front of the crane. View is to the west from near the north opening in the chain link fence.*

- 2.) Sample and characterize contents of full drums at the site. Note that this is an "unknowns" characterization requiring Level B protective gear. At a minimum, overpack compromised or leaking drums and consolidate drum storage, preferably inside a structure.
- 3.) Sample and characterize spilled wastes/materials at the site.
- 4.) Sample and characterize nature and extent of groundwater contamination and/or surface water contamination associated with the site.
- 5.) Possible containment of spilled wastes at the site.

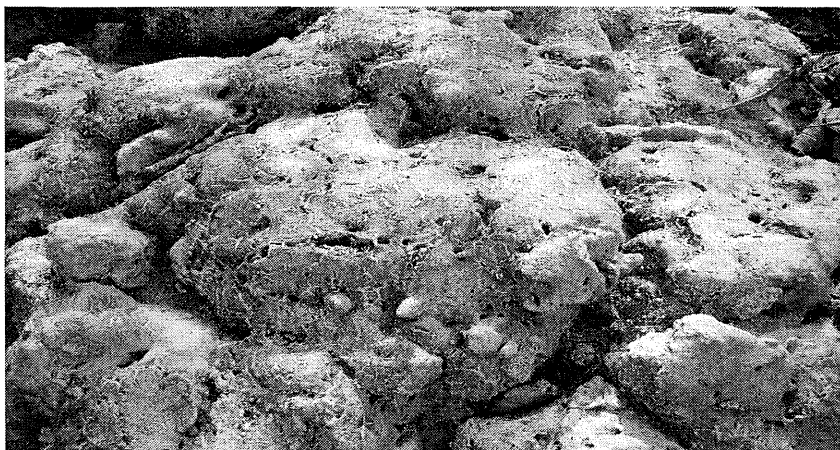
Treoil2 is a close-up of this pile. Sample Treoil 01 is of this waste. Another large tank (~20,000 gal.) just north of the rosin pile also appears to contain the same material. There are two large panels cut out the this tank making the contents visible. About 40' east of these rosin piles, near the railroad tracks and an abandoned car, are about 17 full 55 gal., bung-type drums and three empty 17-H-type open-top drums. There are also 3-4 empty 17-H drums between the rosin pile and the tank full of rosin totes. This area is accessible from the fenced area of the site through an area near the northeast corner of the site fence that has been removed. There is a track leading to this area from within the fenced area that has obviously been used for vehicle traffic. The area can also be accessed from the railroad tracks by the public.

Treoil2: Close-up of rosin pile in Treoil1

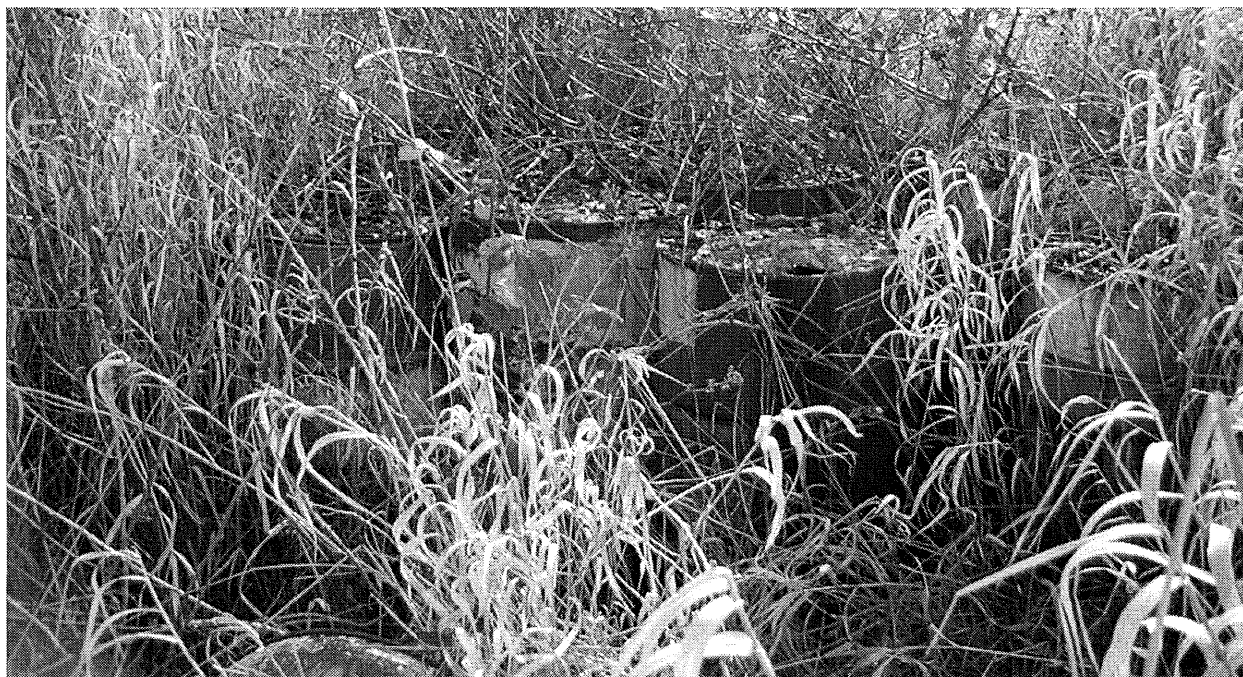
Treoil3a: drums in field north of fenced area near railroad tracks. Contents unknown. This photo is a cropped version of Treoil3. View is to the southeast.

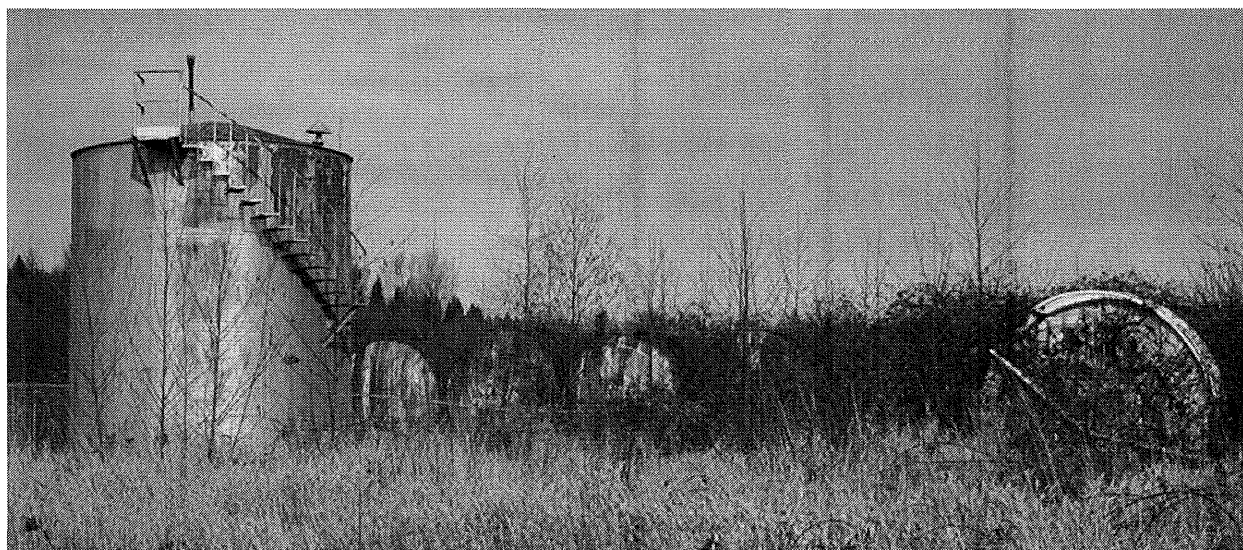
Treoil4a: Abandoned ASTs at the site. Tanks in the background are also visible in Treoil1. The rosin pile in Treoil1 is just north of the background tanks. This photo is a cropped version of Treoil4. View is to the north. The north side of the site chain link fence is visible between the tanks in the foreground and the background tanks.

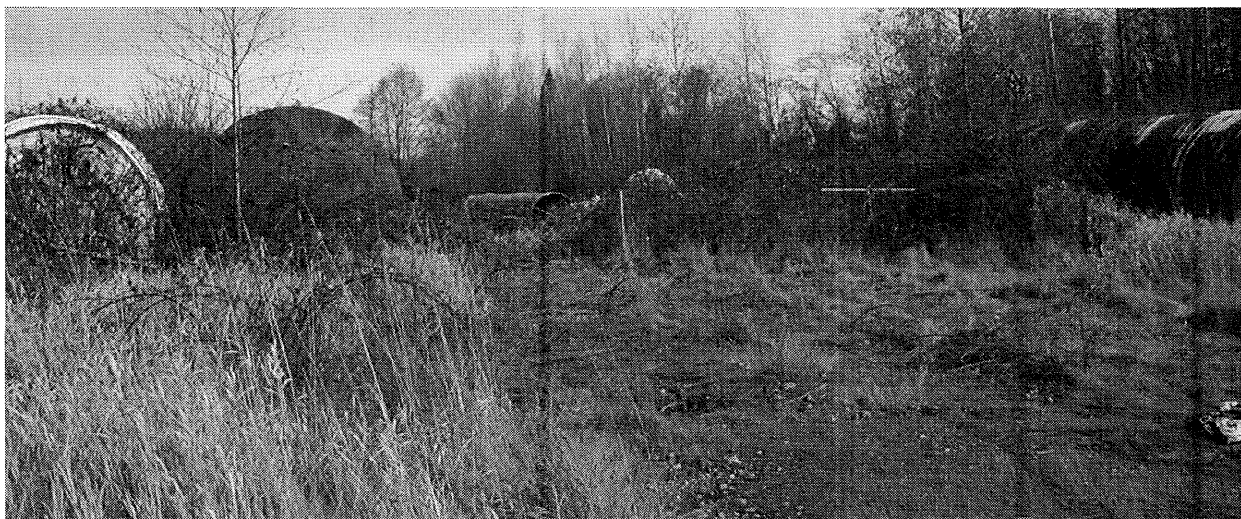
Treoil5a: Photo of opening at northeast corner of fenced area showing opening in the chain link fence that allows access to the site even when the entry gate is locked. Additional abandoned ASTs are shown in this photo. The drums outside the fenced area shown in Treoil3a are near the large section of fiberglass pipe in the upper center of this photo. View is to the north.

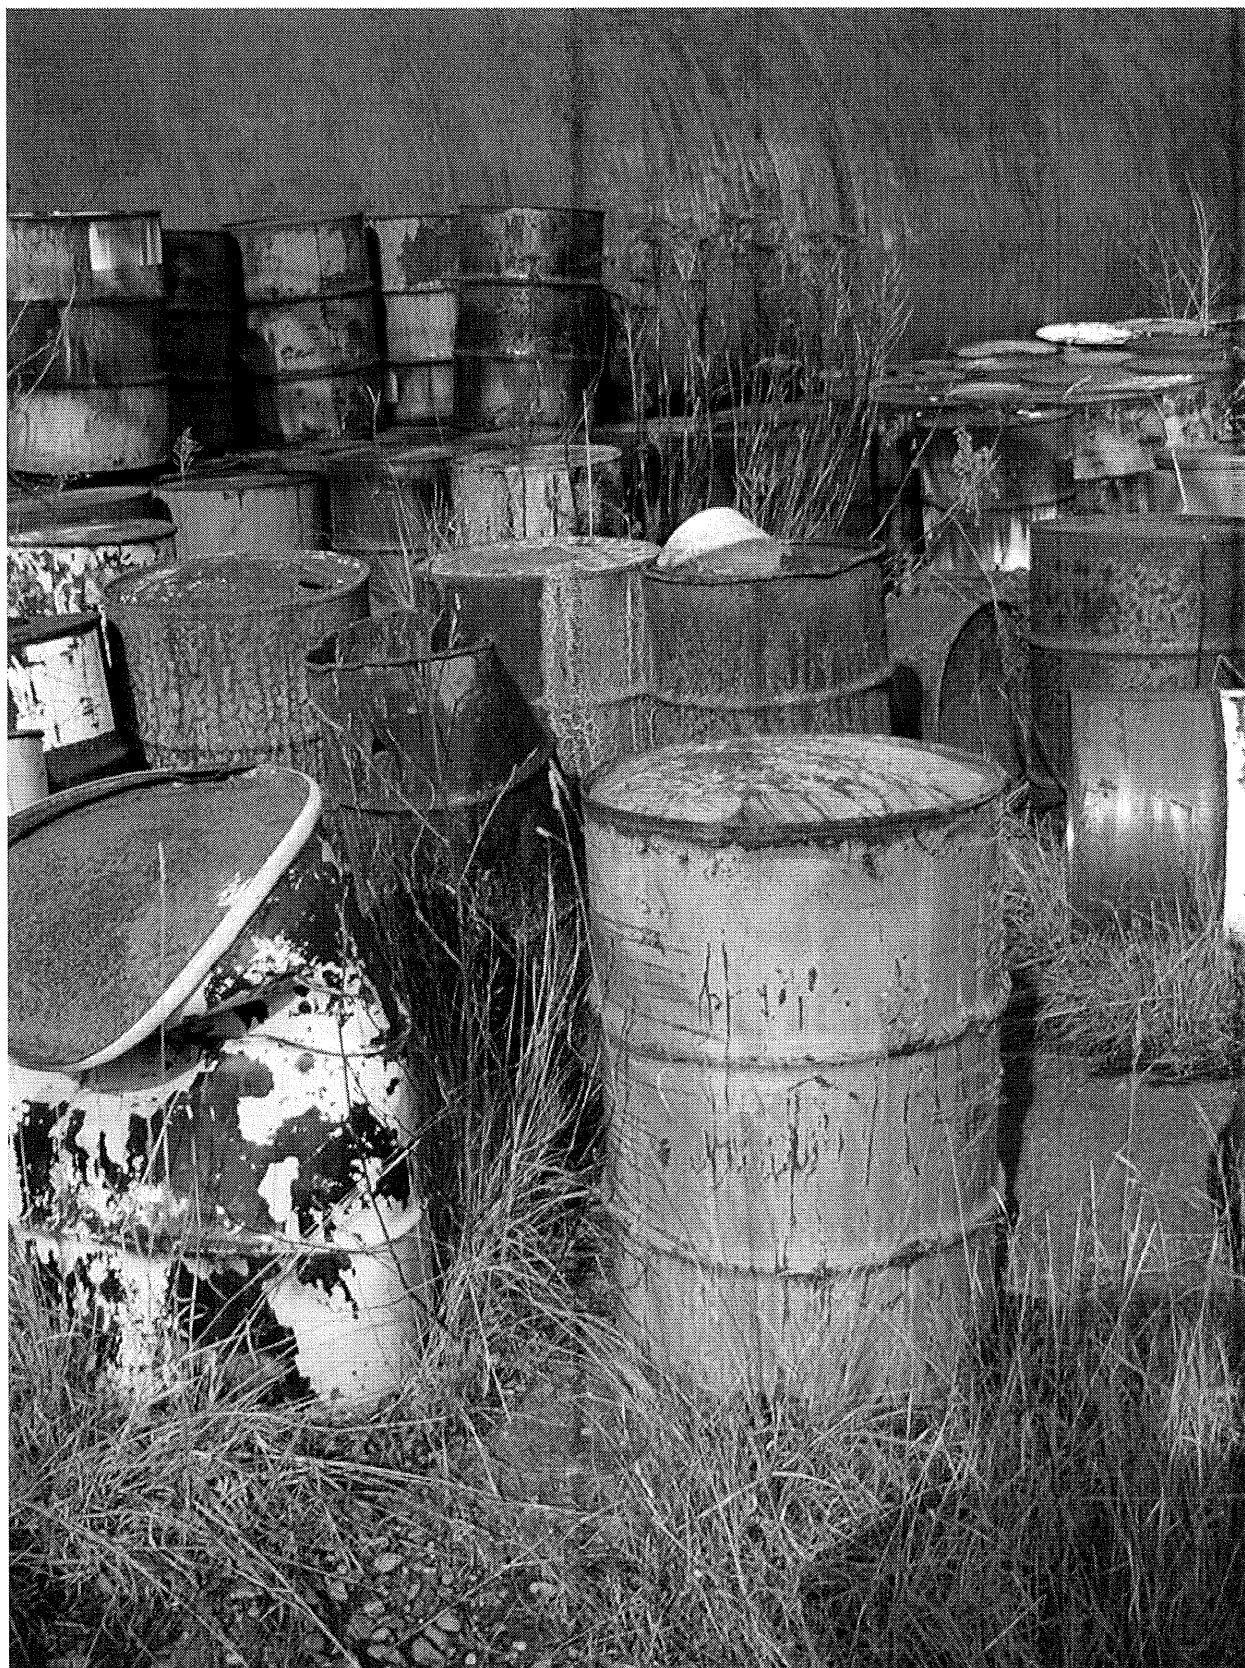
Treoil7: Detail of drums shown in Treoil6a, and spillage to the ground from drum leakage. Note bulging and leaking drums. View is towards the northwest.

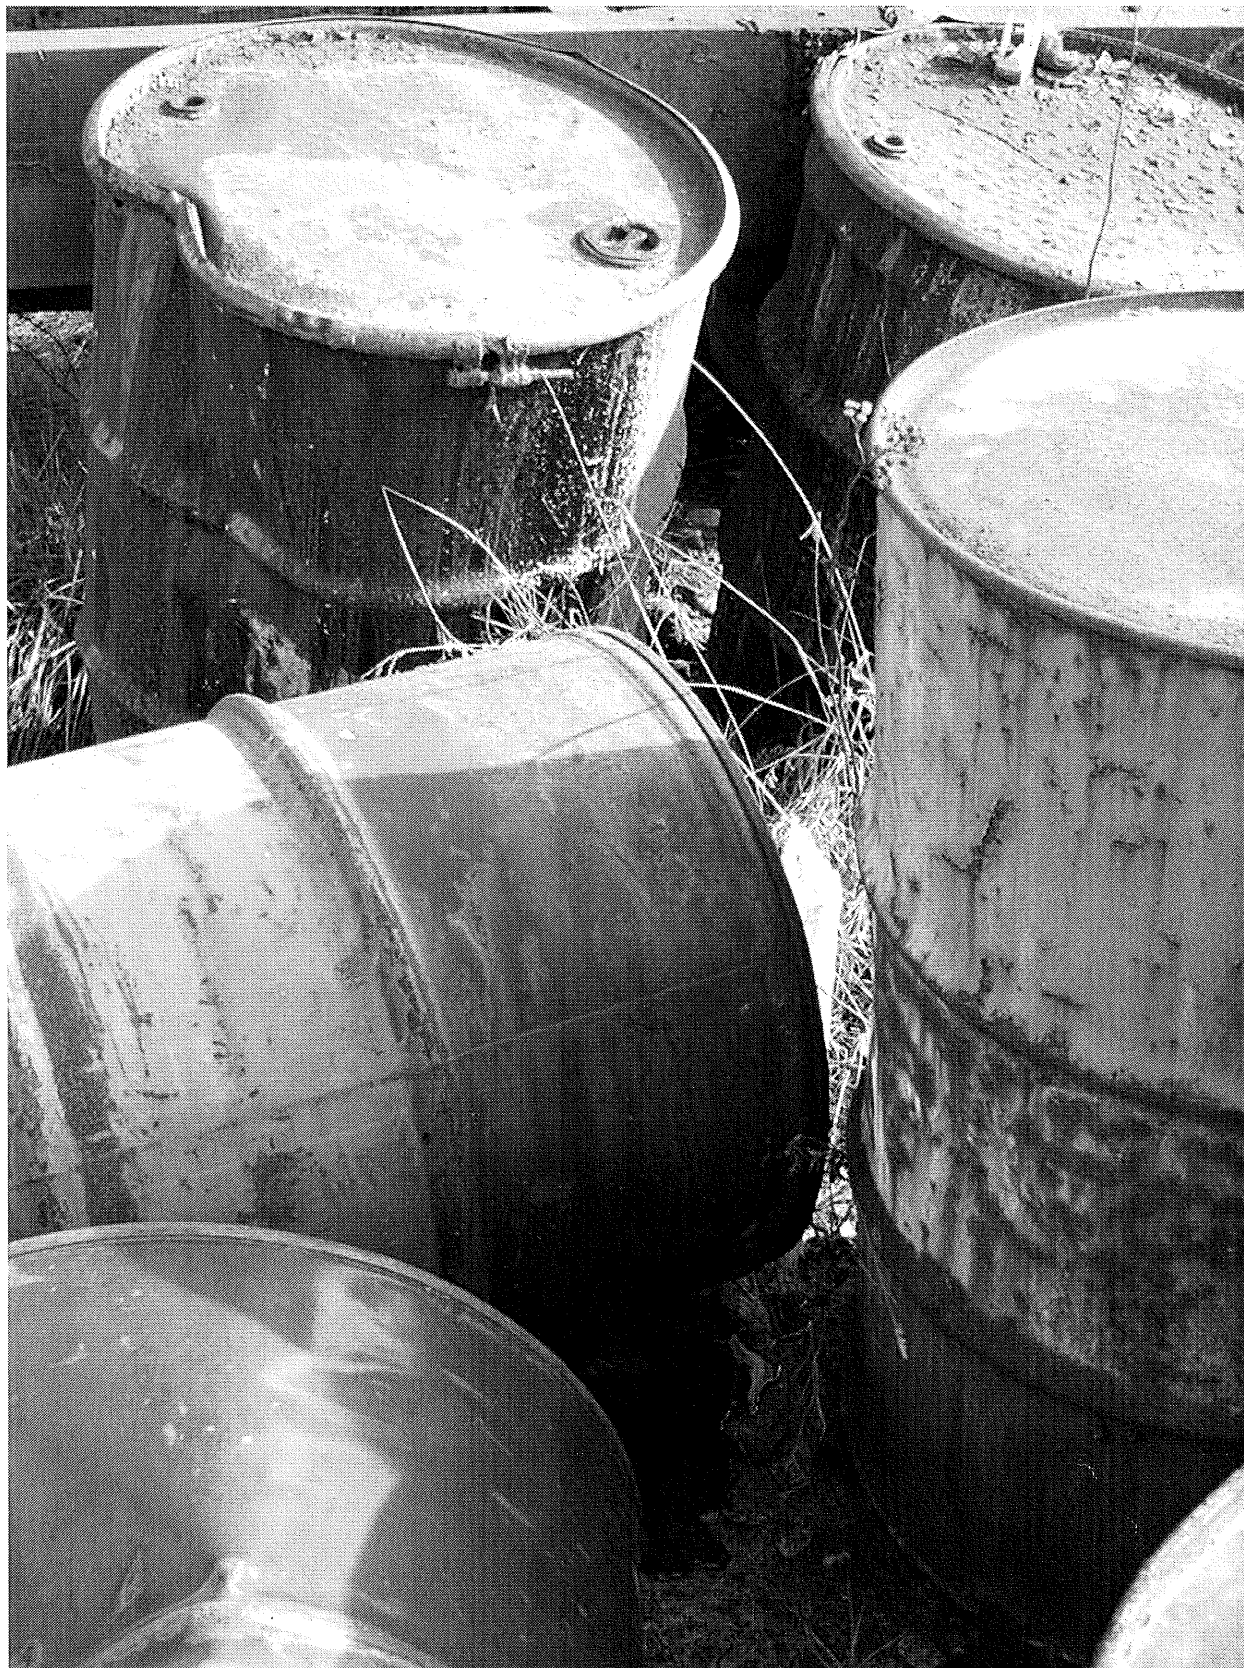
Treoil8: More bulging and leaking drums in the “200 Drum Area” shown in Treoil6a and 7. View is to the northeast.

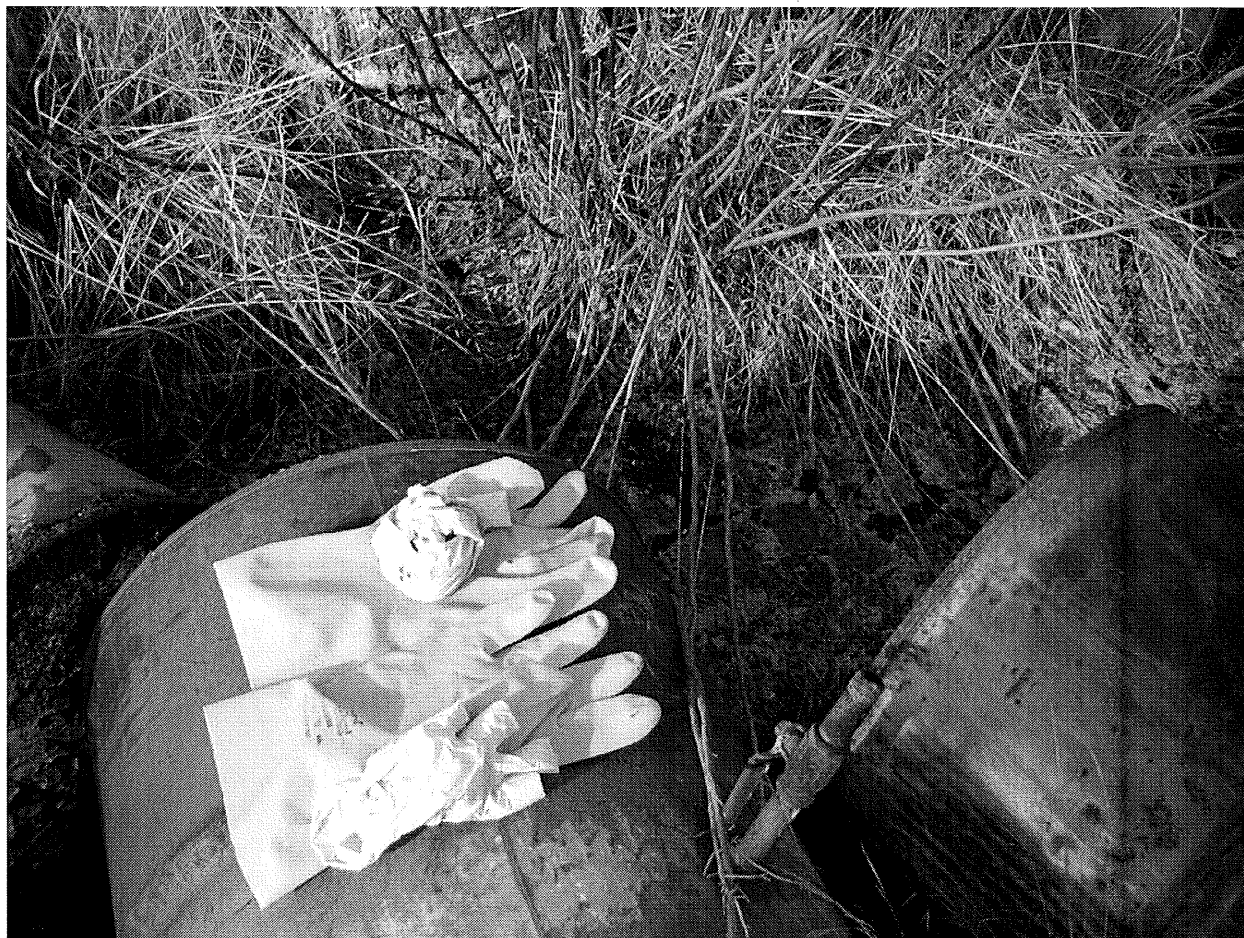
Treoil9: Sample Treoil2 was collected from the dark brown/amber viscous liquid/semisolid in the "V" between the two drums in this photo. This location is within the 200 Drum Area. View is to the northwest.
